RESEARCH MEMORANDUM

OPERATION OF AN EXPERIMENTAL AIR-COOLED TURBOJET ENGINE

AT TURBINE-INLET TEMPERATURES FROM 2200° TO 2935° R

By Reeves P. Cochran, Robert P. Dengler, and Jack B. Esgar

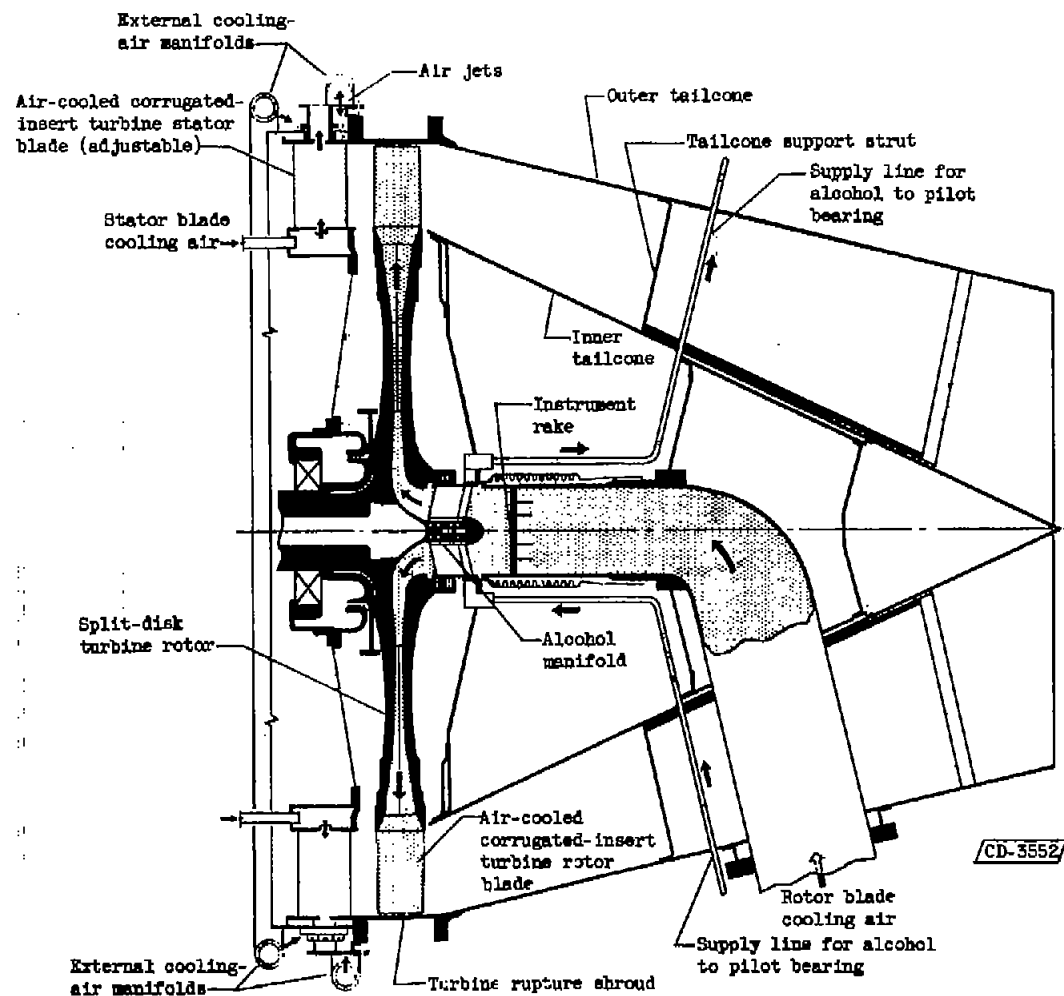
Figure 1. - Schematic view of air-cooled turbine component and tailcone.

Air-cooled turbine rotor assembly. - An air-cooled turbine rotor assembly had previously been built and tested at sea-level static conditions as a part of the NACA research program on turbine cooling (ref. 3). This turbine assembly was used in this investigation. A schematic view of this part of the engine is shown in figure 1. Figure 5 shows the rotor installed in the test engine.

The turbine rotor was a split disk with a downstream cooling-air supply (figs. 1 and 5). Each disk was fabricated from a composite production rotor for this engine consisting of an SAE 4340 hub section and a Timken 16-25-6 rim section. A more detailed description of the turbine rotor is given in reference 3. A 4.0-inch-diameter hole was provided in the center of the downstream (rear) half of the rotor for introduction of the cooling air. The tube ducting air to the rotor was held concentric with the axis of the turbine rotor by pilot bearings (fig. 5) mounted on the small shaft protruding through the center of the air inlet. To ensure proper lubrication of these bearings even when extremely low temperatures (around 295° R) were reached in the refrigerated cooling air, it was necessary to insulate the bearing housing from the direct effects of this cold air. This was accomplished by the addition of a manifold encompassing the bearing housing (fig. 1). Alcohol was circulated in this manifold to provide a thermal shield between the bearing housing and the refrigerated cooling air.

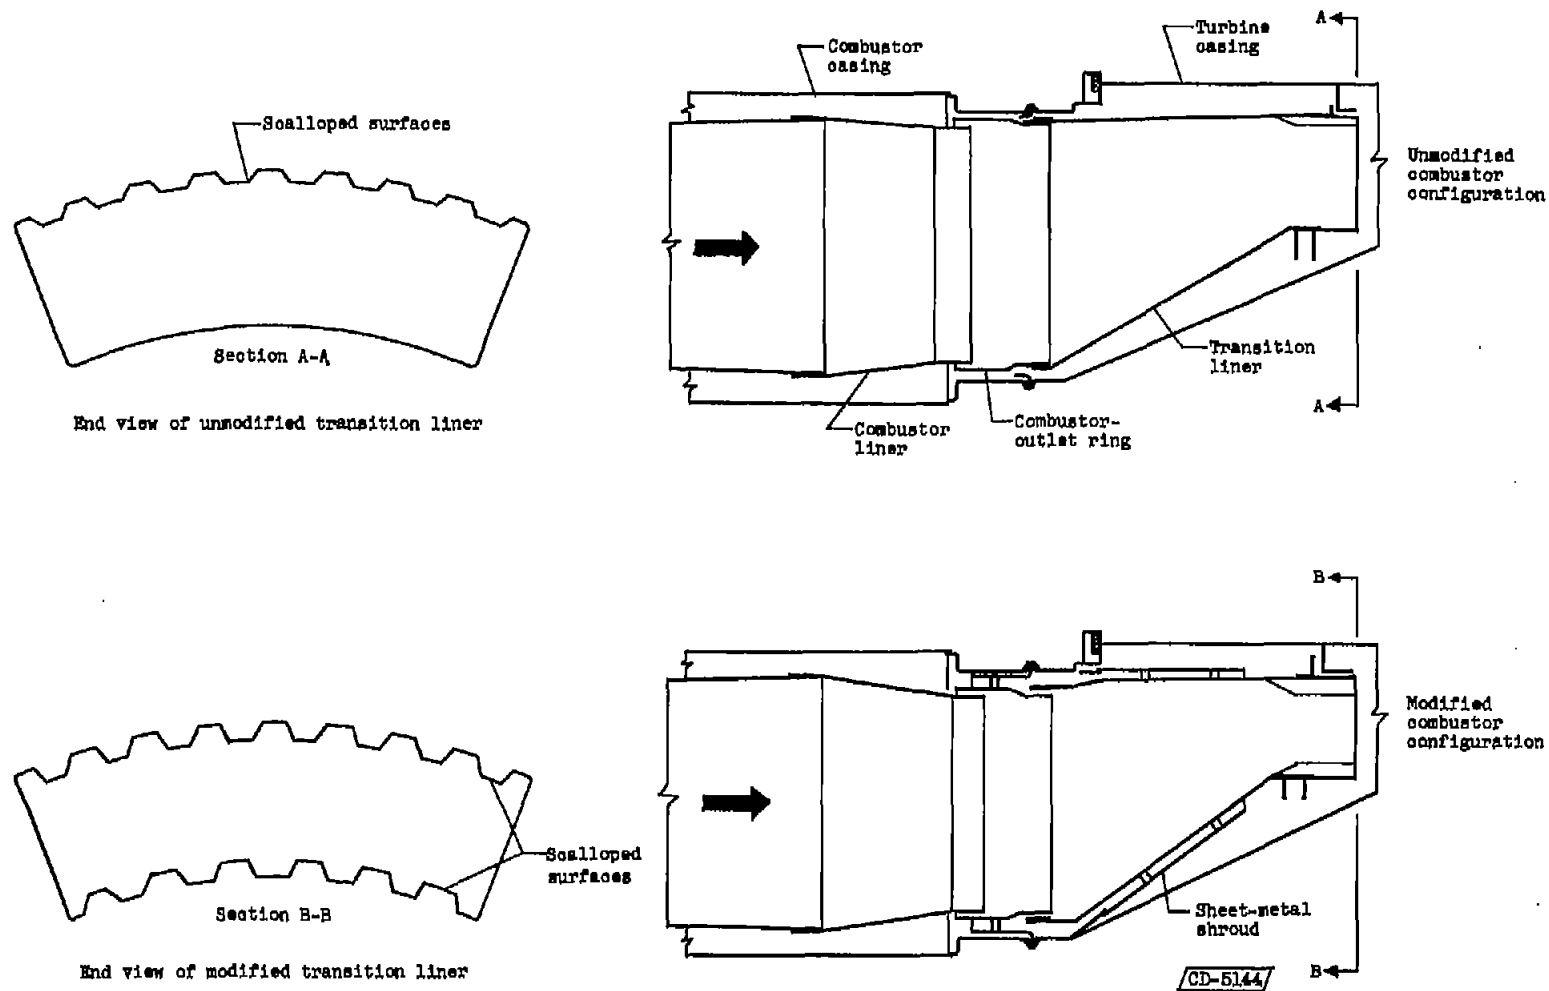
(a) Cross-sectional drawings of combustors and liners.

Figure 2. - Modified and unmodified production-model tubular combustors and transition liners.

cooling, production-model tubular combustors for this engine were modified as described in reference 9 to permit a larger flow of secondary (cooling) air around the inner and outer peripheries of the combustion chambers. Figure 2 gives a comparison of the production-type and the modified combustors. The support struts of the unmodified transition liner (fig. 2(b)) were removed in the modified version as a precautionary measure, that is, to prevent the possibility of these struts failing and damaging the turbine stator and rotor blades during operation at the proposed high turbine-inlet temperatures. The diameters of the aft end of the combustor liner, the combustor-outlet ring, and the forward end of the transition liner were reduced to increase the annular area between the liners and the combustor casings. A sheet metal shroud was built around the transition liner to direct the cooling-air over the outside surface of the liner. The scalloped surface on the outer radius of the aft end of the transition liner was more deeply drawn for added cooling-flow area, and scallops were also formed on the surface of the inner radius of the liner.

There were no thermocouples located on the turbine casing or on the modified combustor and transition liners (figs. 2 and 4), but the heat patterns observed on these parts during and at the conclusion of the investigation gave a good indication of the range of the wall temperatures. The forward portion of the turbine casing which encloses the transition liners (fig. 4) was protected from the hot gases by the large flow of cooling air around the modified combustion system. No heat pattern was observed here during operation. At the rear portion of the turbine casing where the adjustable stator blades were mounted, this cooling air was not

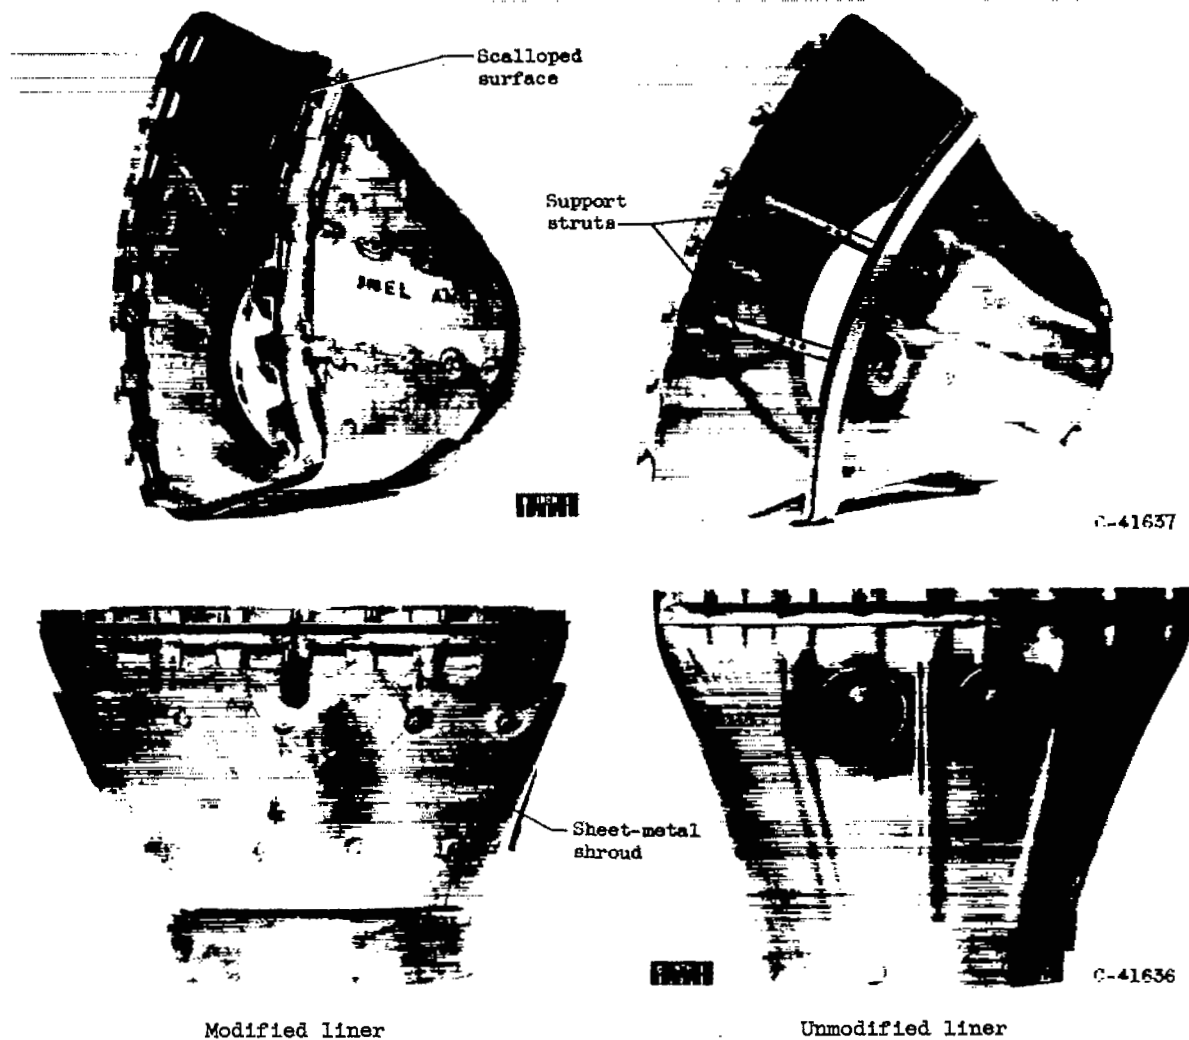
(b) Photographs of sheet metal transition liners.

Figure 2. - Concluded. Modified and unmodified production-model tubular combustors and transition liners.

in direct contact with the casing (fig. 4). Excessive heating of this region was observed, and large radial expansion resulted, as will be discussed in connection with the turbine stator. The heat patterns observed on the modified combustor and transition liners at the conclusion of the investigation indicated that at no time were the wall temperatures excessively high. There were no signs of erosion or deformation on these parts due to the high temperatures involved. The modified combustor liners satisfied the need for cooling to adjacent engine parts at least for this short-term test.

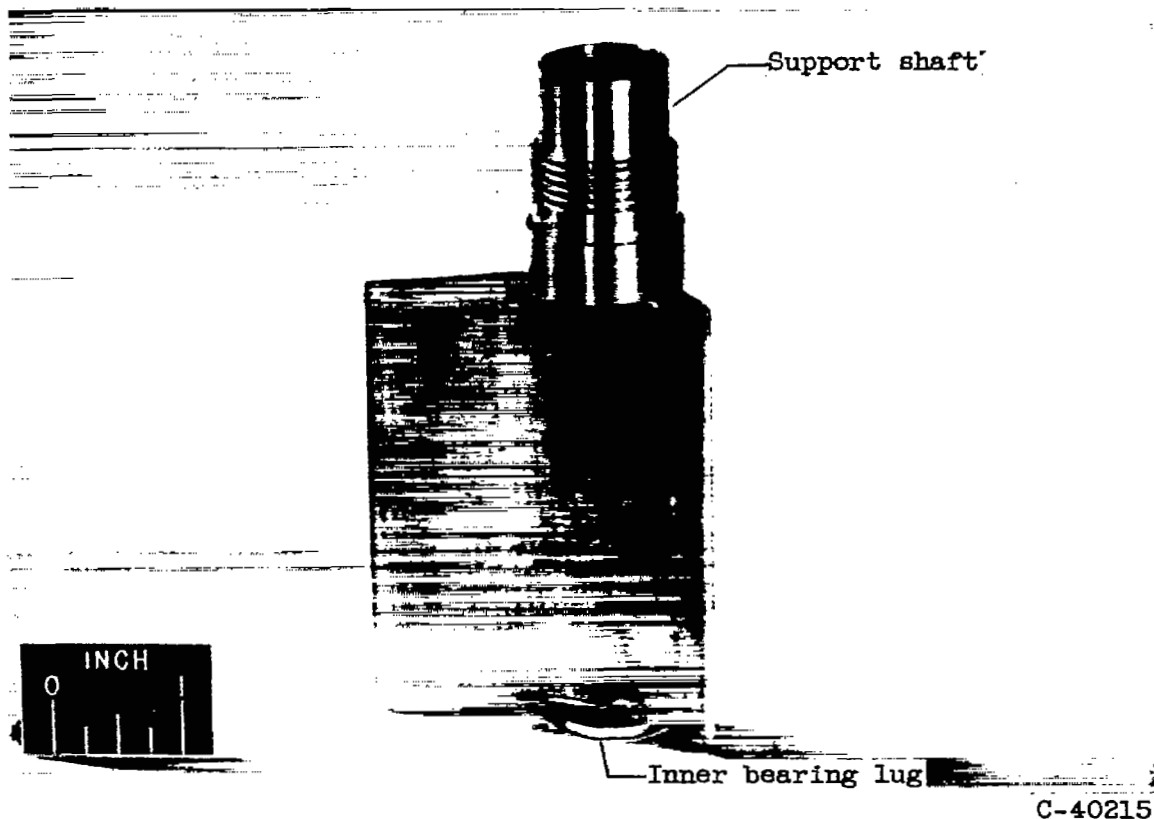
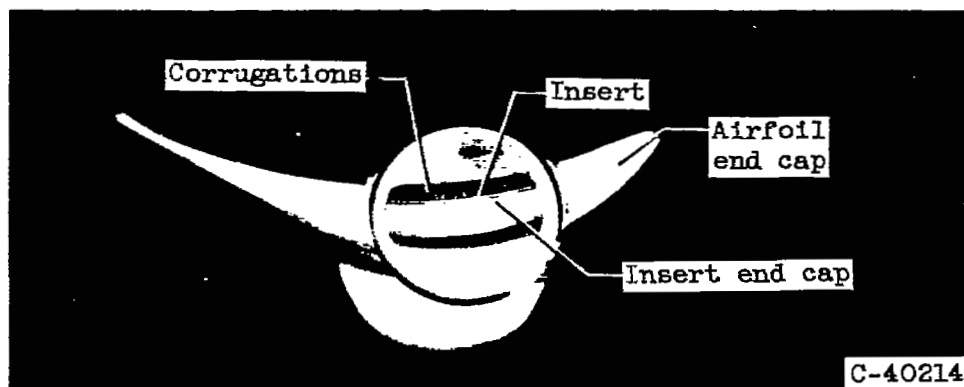
End view of stator blade showing cooling-air entrance

Figure 3. - Adjustable air-cooled corrugated-insert turbine stator blade.

The stator blades (fig. 3) were fabricated of a high-temperature alloy, N-155. The airfoil shell was formed in two halves of 0.020-inch-thick sheet stock. Corrugated heat-transfer surfaces (figs. 3 and 4) 0.010-inch thick with an amplitude of 0.070 inch and a pitch of 0.070 inch were fitted to the inside surfaces of both halves of the shell. A 0.010-inch-thick insert that extended from near the hub to near the tip of the blade (see fig. 4) was attached to the inner surface of the corrugations. This insert was capped at both ends; thus the cooling air was forced to flow over the corrugated heat-transfer surfaces in passing through the blade. The space between the end cap on the airfoil shell and the end cap of the insert at both the hub and tip of the stator blade (fig. 4) was intended to provide for the distribution of the cooling air over the entire chord length. The blade was assembled with a bearing lug at the root and a support shaft at the tip. All joints in this blade assembly were made with Nicrobraz except the leading- and trailing-edge joints which were heliarc welded.

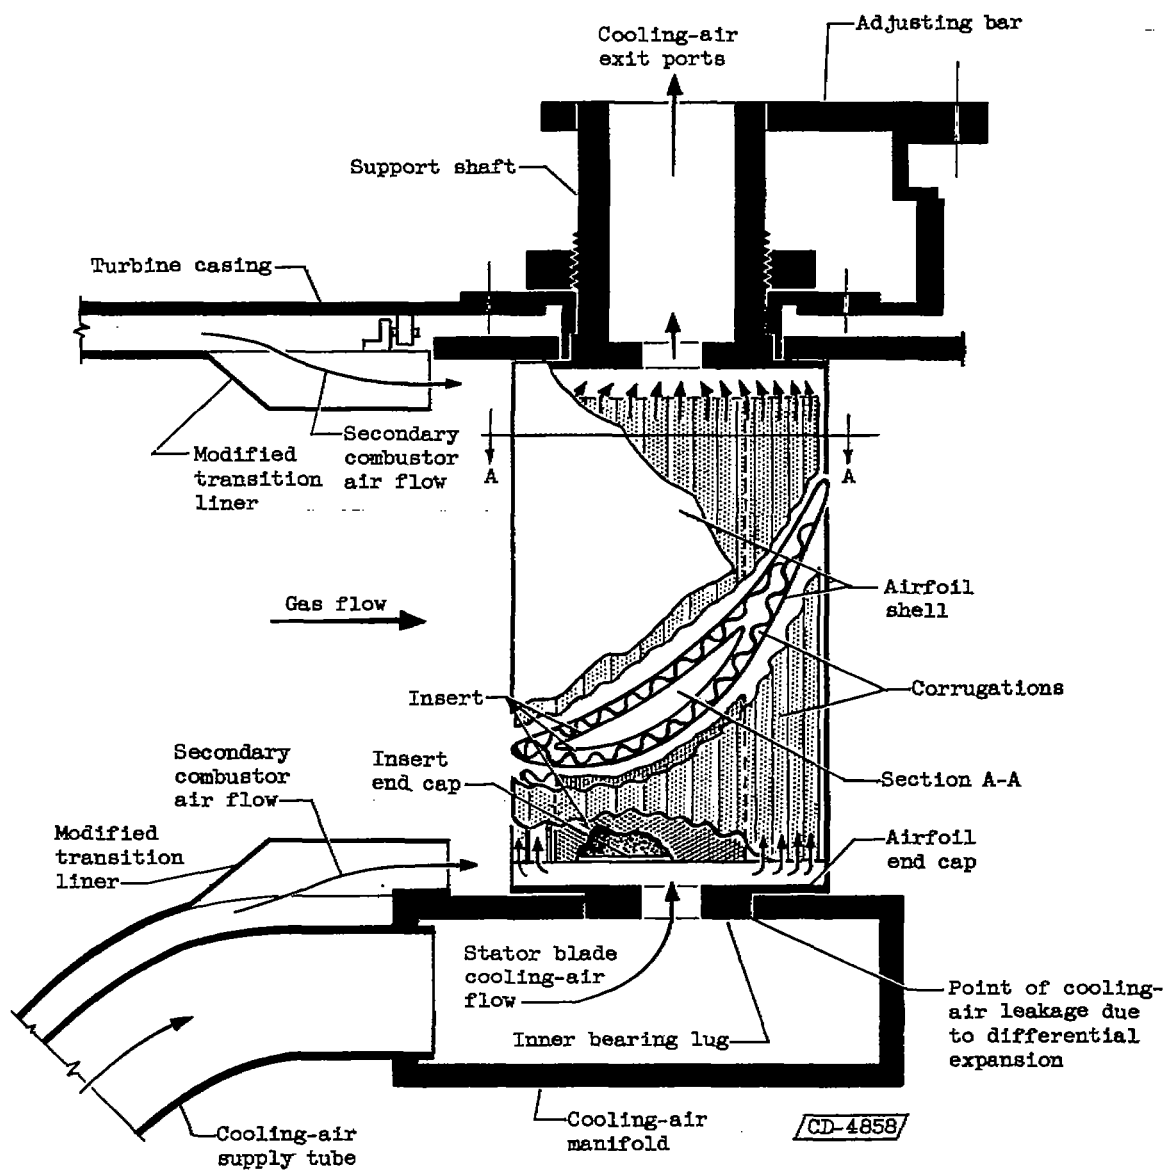
Figure 4. - Schematic view of adjustable air-cooled stator assembly.

A cross-sectional sketch of the air-cooled stator assembly is shown in figure 4, and a view of the stator assembly installed in the test engine can be seen in figure 5. The cooling air for the stator blades was supplied from the laboratory service air system (pressures near 55 lb/sq in. abs) through eight $\frac{15}{16}$ -inch-inside-diameter tubes to eight

The individual stator blades were supported on the outer casing and contacted the inner radius only at a sliding joint (fig. 4). There was the possibility that the relatively short (about 1/8 in.) inner bearing lug would not be of sufficient length to accommodate the differential expansion between the inner and outer radii of the stator assembly. Because of the required assembly procedure, this condition could not be remedied or improved without considerable redesign.

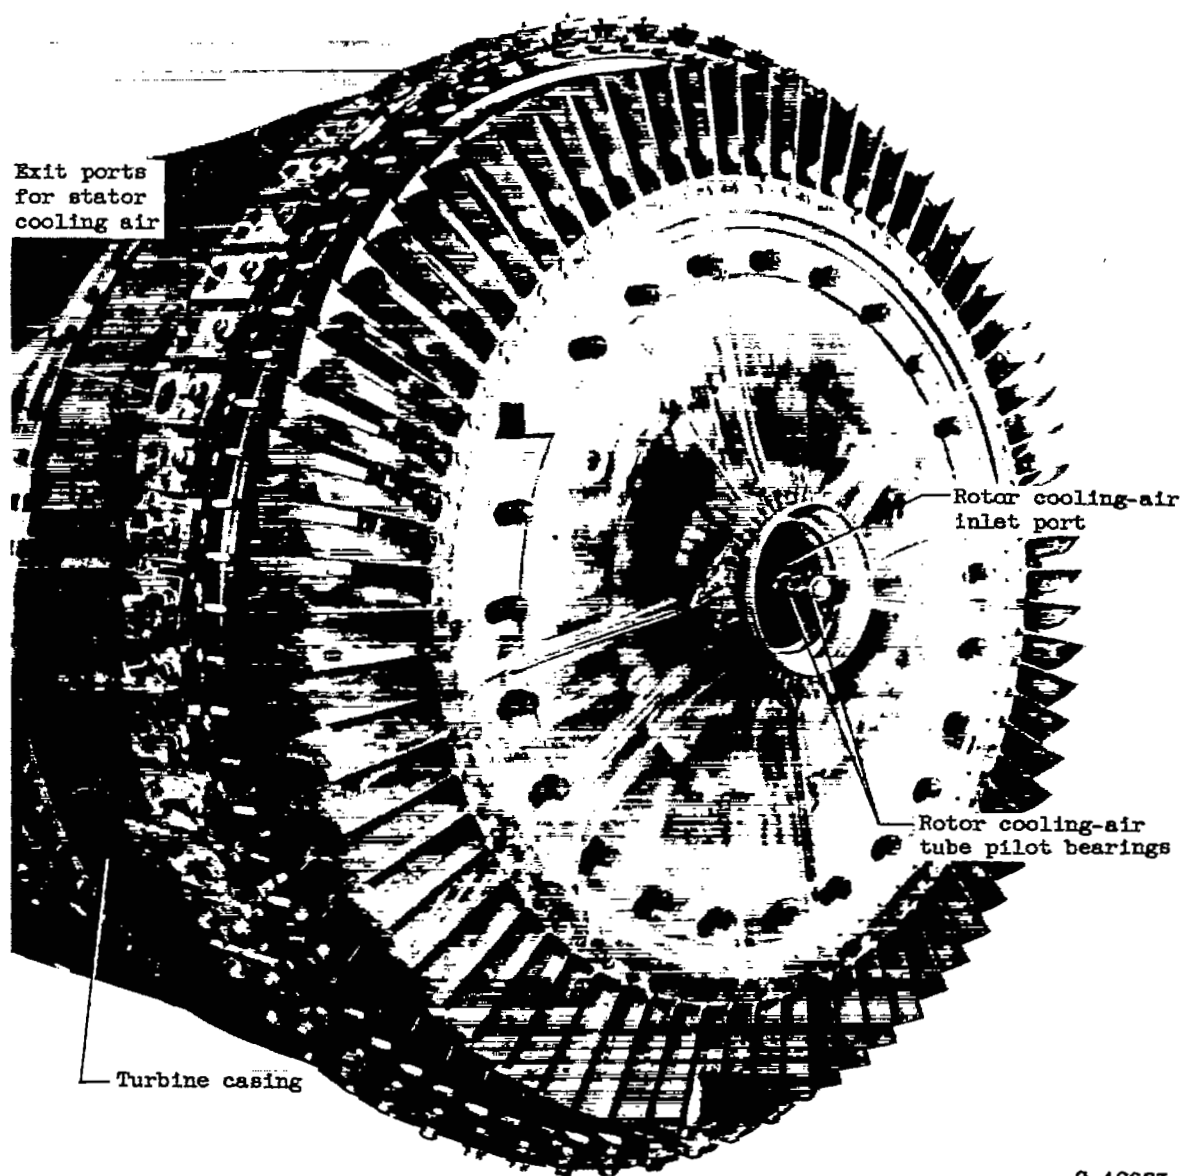
C-40623

Figure 5. - View of air-cooled stator and rotor assemblies in test engine.

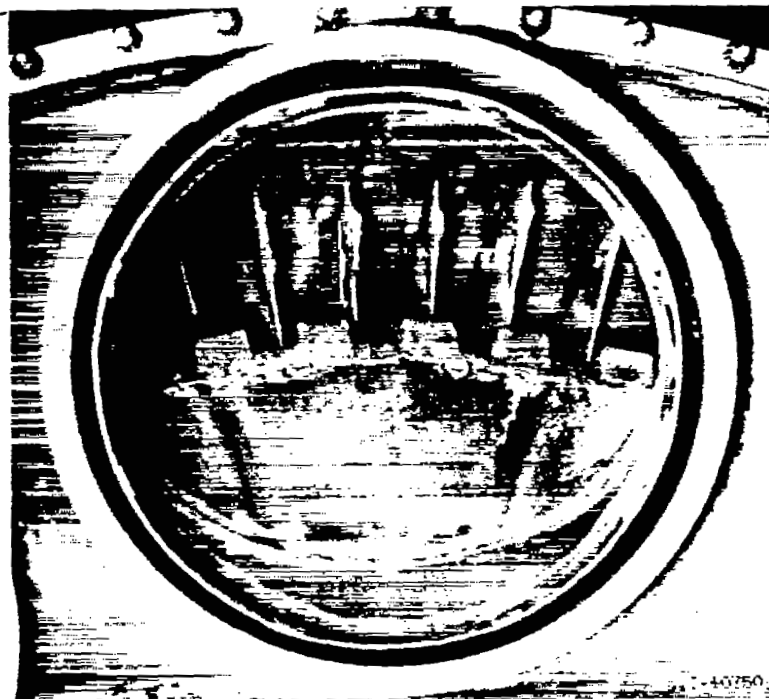
(a) Most severely damaged sector.

Figure 7. - Views of leading edges of stator blades at conclusion of investigation.

Figure 7 shows views of the leading edges of the stator blades behind two of the combustion chambers. Figure 7(a) shows the section with the most severe damage (exclusive of the sector in which the failure described above occurred), and figure 7(b) shows the sector with the least damage. The damage patterns shown here indicate that the peak temperature of the gas profile at the stator inlet was between one-half and three-quarters of the span distance from the hub to the tip of the blade. Severe burning of the leading edges was apparent on more than half the blades in the stator assembly.

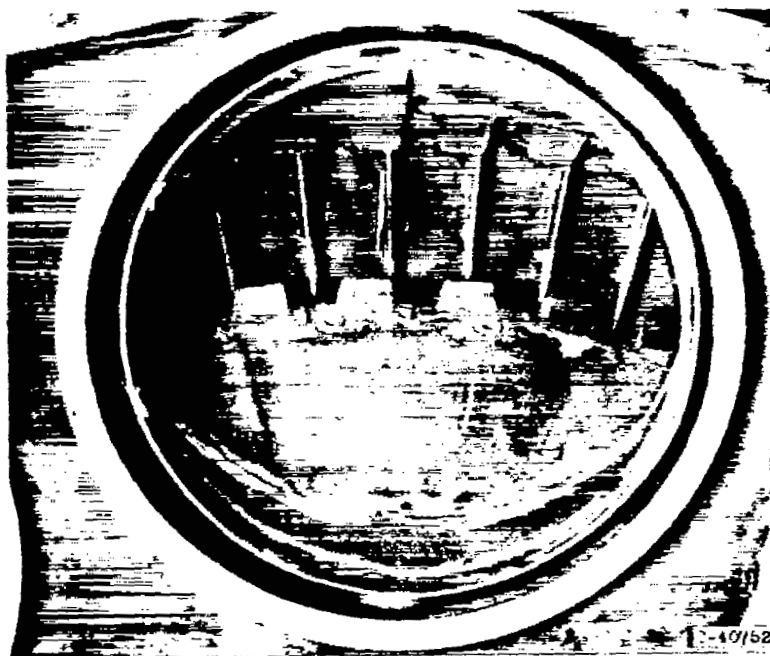
(b) Least damaged sector.
